Zerust® ReCAST - SSB

CORROSION MANAGEMENT FOR ABOVEGROUND STORAGE TANKS

PREVENTION OF SOIL SIDE BOTTOM CORROSION OF ABOVEGROUND STORAGE TANKS (ASTs)

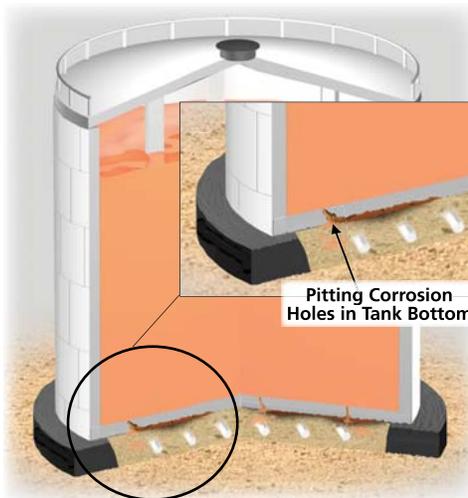
PROBLEM

Corrosion of Soil Side Bottoms (SSBs) of Above ground Storage Tanks (ASTs) causes the formation of holes that allows product leakage into the environment. This specific type of corrosion is called soil side pitting corrosion, and forms in the gaps or "vapor spaces" between the metal tank bottom and the soil/concrete slab it rests on. These "vapor spaces" are formed when the metal bottom flexes up and down when product is filled and removed from the AST. Traditional cathodic protection (CP) systems have proven to be ineffective in these situations because CP cannot function when vapor space gaps break the essential electro-chemical circuits formed by direct contact between the soil (electrolyte) and the metal tank bottoms. This problem can be further exacerbated by the use of bituminous beds below the tank bottoms. Acids from the surrounding soil will seep through the beds to directly attack the metal tank bottoms. Alternatively, in coastal areas, high ambient humidity and/or rainfall causes moisture to seep between and separate the metal bottoms and the bitumen (called "sweating"). This problem also manifests itself with double bottom constructions, when the sand bed between the two bottoms becomes saturated with water over time and causes corrosion of the soil side of the upper tank bottom.

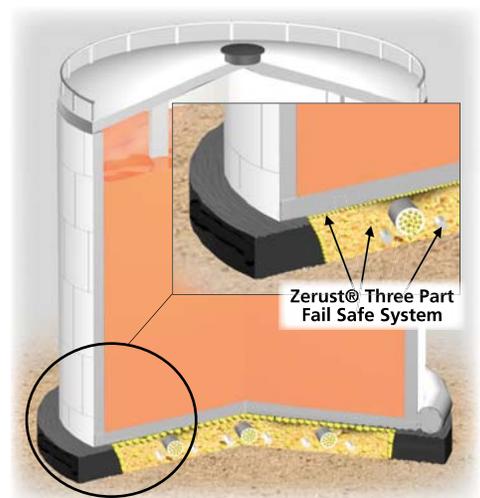
SOLUTION

Three Part Fail-Safe System: The client deployed NTIC's proprietary Zerust® ReCAST-SSB inhibitor in the sand bed between the two bottom layers. The inhibitors were implemented at the same time as the replacement of the bottom. The full system consists of three parts:

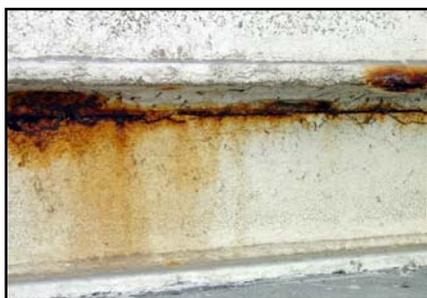
ACTUAL CLIENT SITE CORROSION: The sand bed between the two tank bottoms became saturated with water, causing significant pitting corrosion in the upper tank bottom.

CORROSION DAMAGE ON THE UPPER BOTTOM PLATES OF THE ABOVEGROUND STORAGE TANK

COST IMPACT OF ACID GAS CORROSION: The pattern of rust indicated that pitting corrosion had either eaten through, or considerably weakened, the bottom plate meaning that patchwork repairs would be insufficient and that the entire bottom had to be replaced.

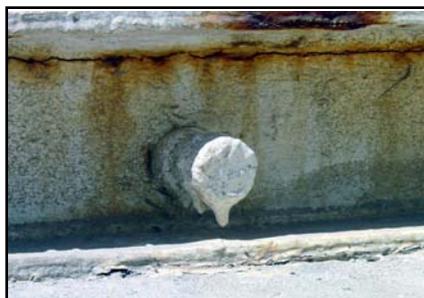
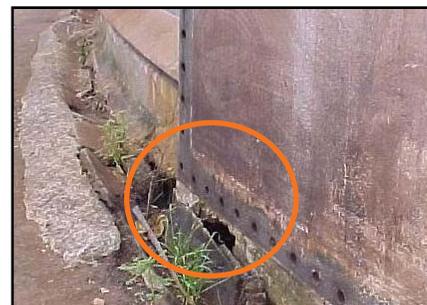
CORROSION HOLES IN THE AST BOTTOM

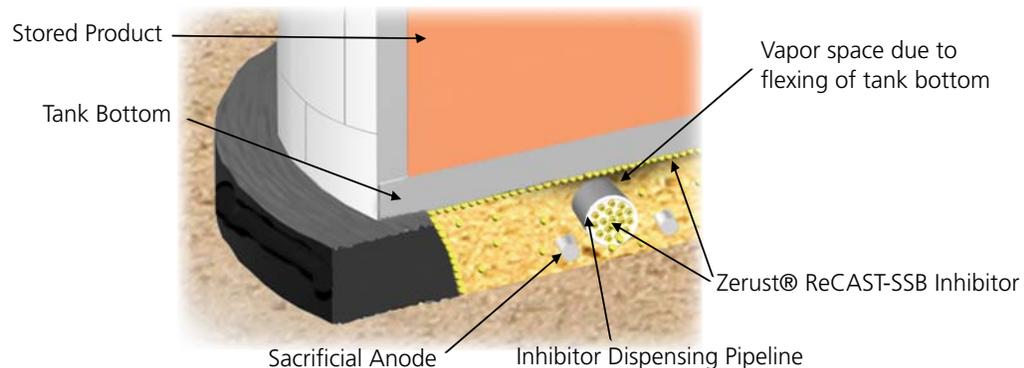
The full three-part system allows for inhibitor concentrations to be adjusted through a tank bottom inhibitor delivery system with a delivery station that is installed outside the tank base. This is critical to maintain the efficiency of corrosion mitigation throughout the life of the tank. NTIC periodically monitors the effectiveness of this solution by analyzing the data emitted from sensors implated in the tank bed. NTIC also employs other measurement techniques that do not require stoppage of tank operations. Through this combination of technique and technology the NTIC team is able to adjust the system characteristics as required to minimize corrosion.

The initial load of inhibitors are mixed with the sand of the bed during construction of the tank, or replacement of the tank bottom. Additional loads are delivered through a dispensing pipe system installed in the space below the tank bottom. In addition, the proprietary inhibitor mix is ionic in nature and migrates to any area where electrochemical corrosion cells are formed.
